MANUAL ON CONSERVATION AND RESTORATION OF MONUMENTS

Proceedings of an Administrator turned
Conservation Archaeologist cum Museologist

2007

Published by the Government Museum,
Chennai-600 008

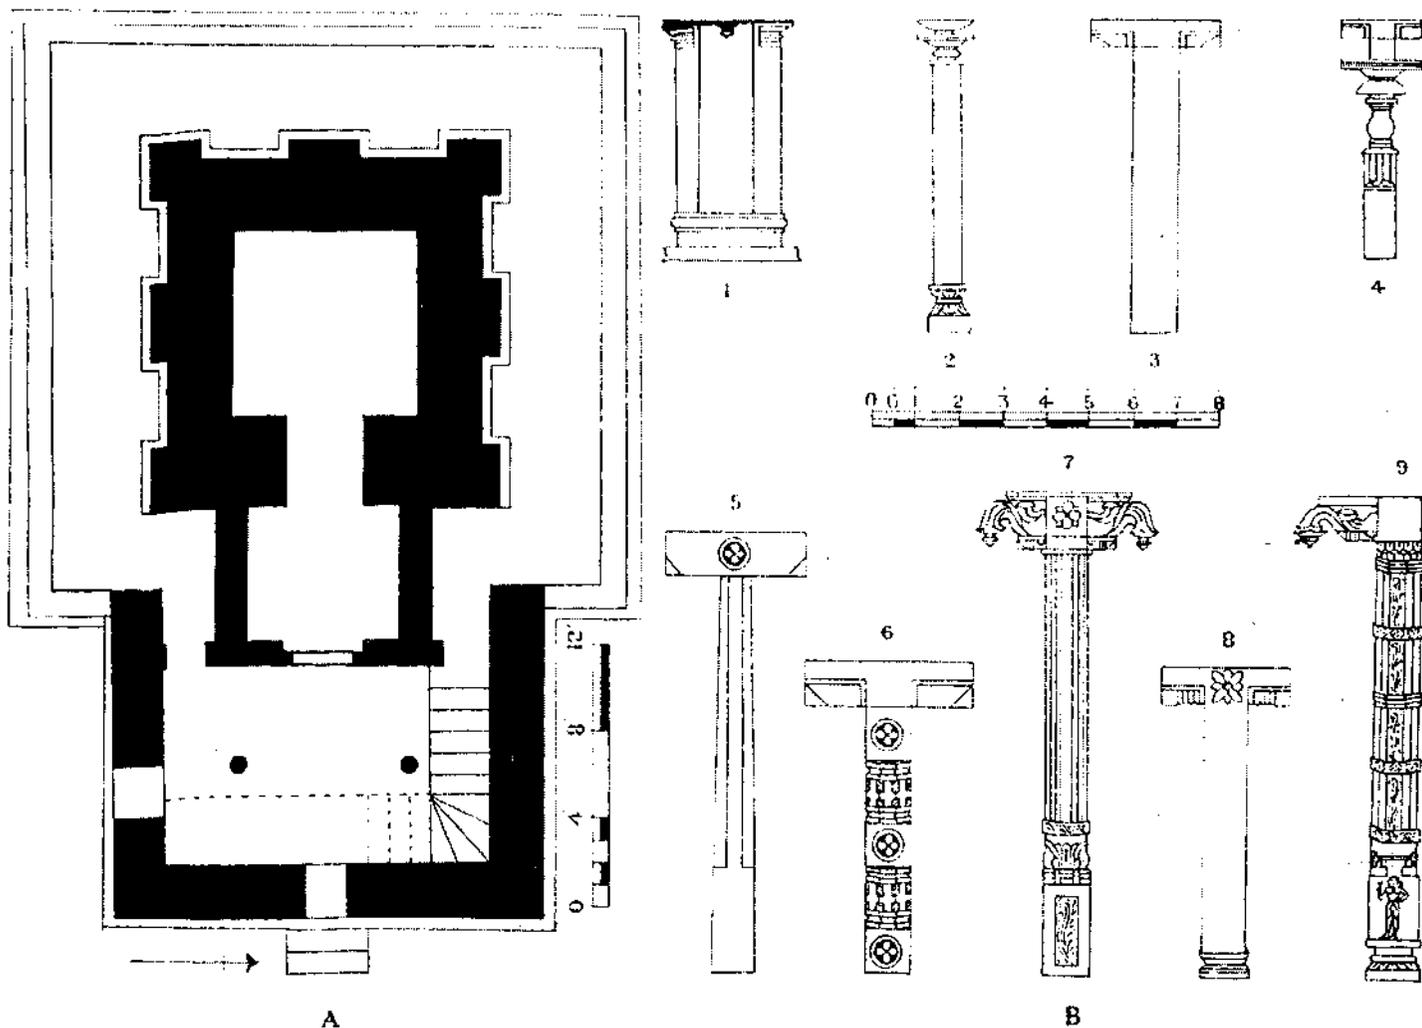
A
PLAN OF CHANDRAPRABHA TEMPLE

B
DETAILS OF ARCHITECTURE.

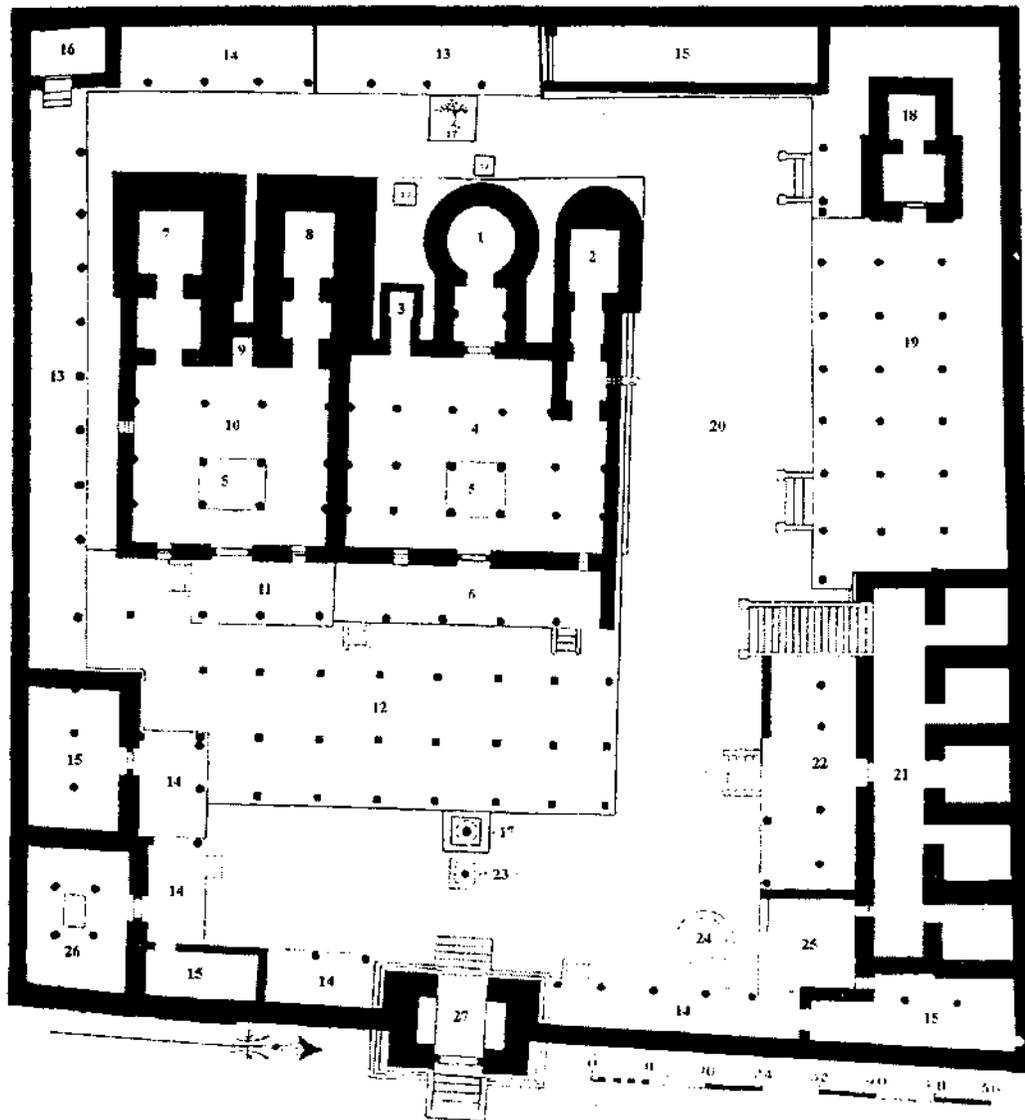
PLATE II.

PLAN OF VARDHAMĀNA TEMPLE.

Thus it would appear that there was an opening on the west wall of the *Ardha maṇḍapa* in front of the present shrine of *Vardhamāna*. The shrines of *Vardhamāna* and *Pushpadanta* are both apsidal, that of *Pushpadanta* (see - Plate II, 2) being smaller than that of *Vardhamāna*. As proof of frequent interference with these shrines till very recently by way of repairs, it may be noted that a little part of the southern wall of the brick shrine of *Pushpadanta* is built of irregular granite pieces loosely laid.

The shrine dedicated to *Dharmadevī*, the *Yakshī* of *Neminaātha* (see - Plate II, 3), is situated in the south of the *Vardhamāna* shrine and is totally different from the other two shrines in that it is very small and square instead of being apsidal. According to local traditions the image of *Dharmadevī* appears to have been introduced into the temple, according to one version, in the thirteenth century A.D. from the *Kāmākshī* temple at Conjeevaram, and according to another in the ninth century A.D., soon after *Śaṅkarāchārya* established the *Kāmakṣī-pīṭha* in the *Kāmākshī* temple, both versions regard *Kāmākshī* temple as having originally been a Jaina shrine dedicated to *Dharmadevī*, the *Yakshī* of *Neminaātha*. The veracity of these two versions is much disputable as the traditions themselves are of late origin, probably two centuries old. These traditions clearly suggest that the image of *Dharmadevī* was a late acquisition to the *Vardhamāna* temple. It is of brick. It has been jointed to the *Vardhamāna-Ardha maṇḍapa* by making a very narrow opening in its west wall.

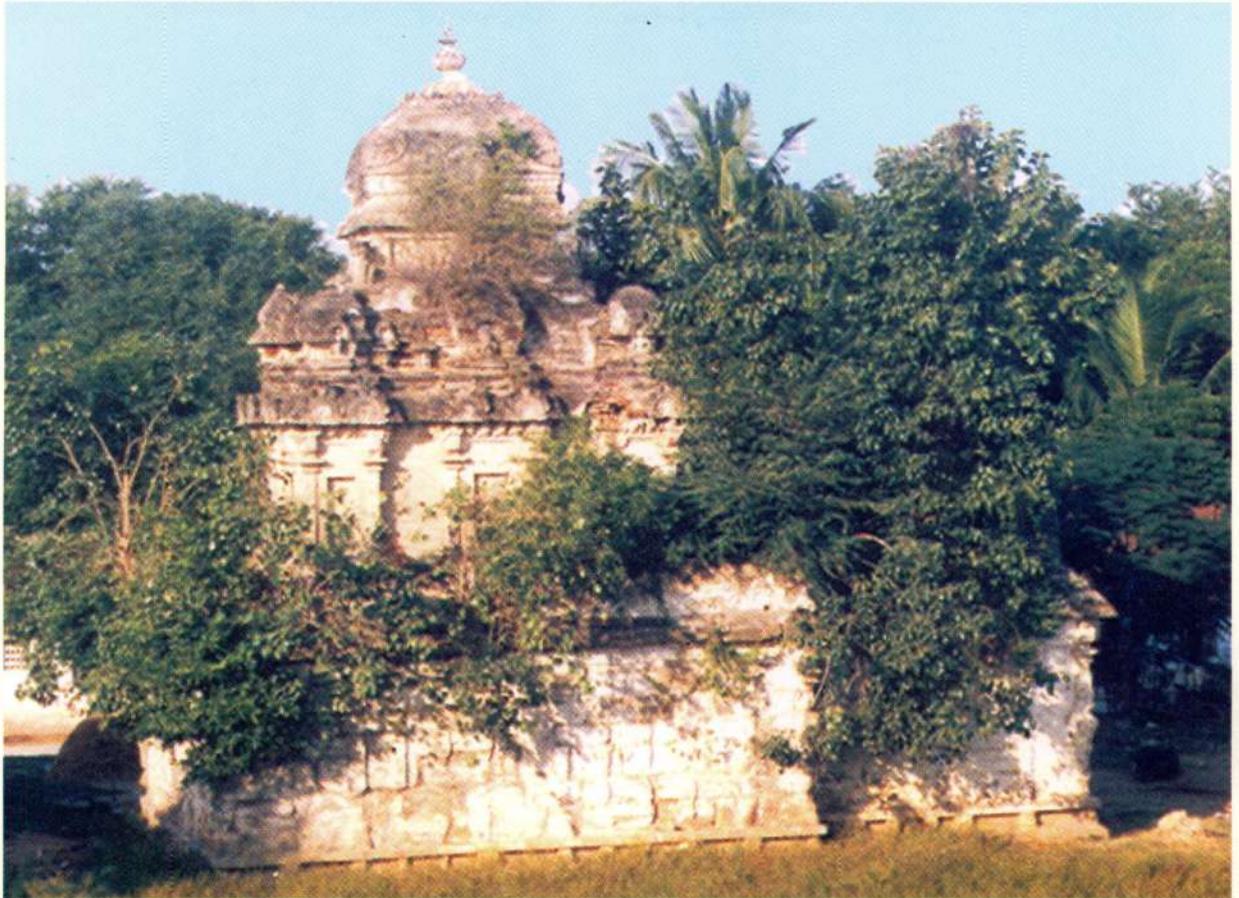
Jain temple of *Chandraprabha* - Before conservation

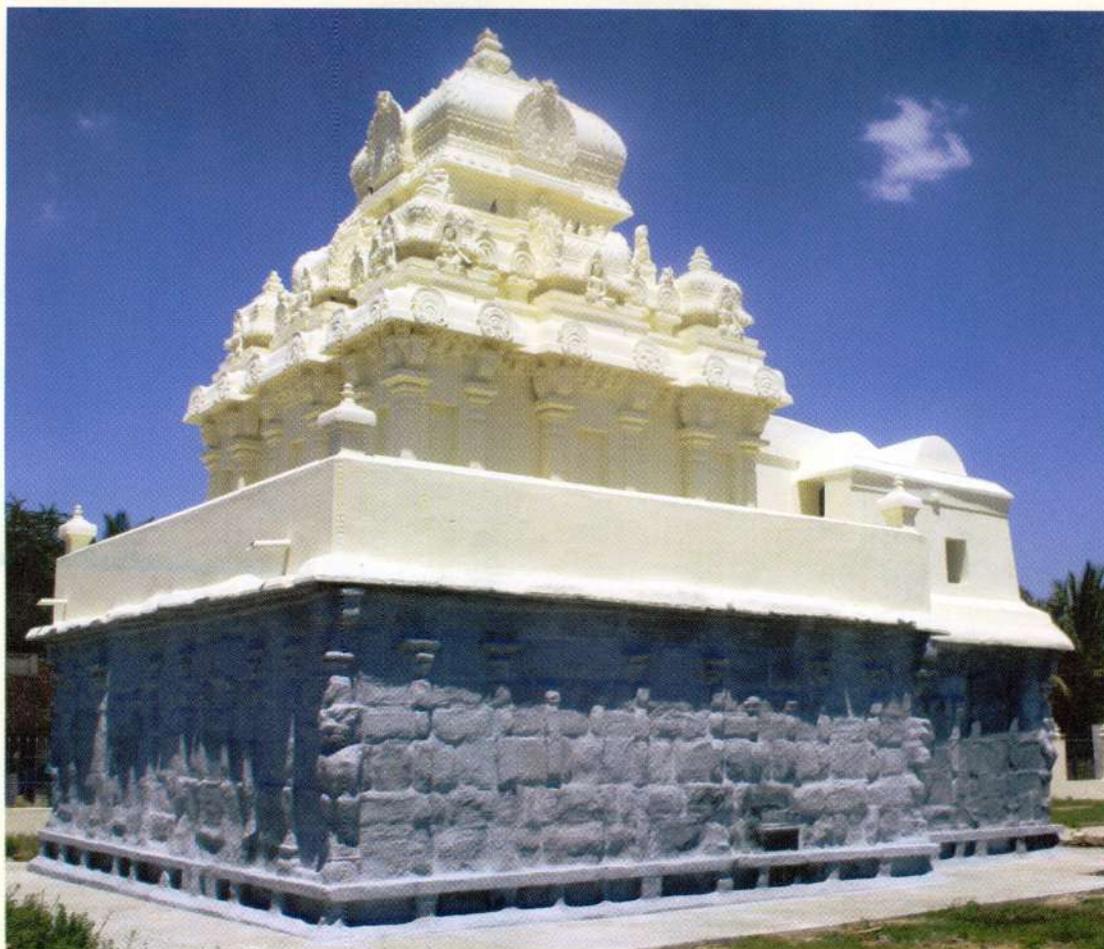
Jain temple of Chandraprabha - After conservation

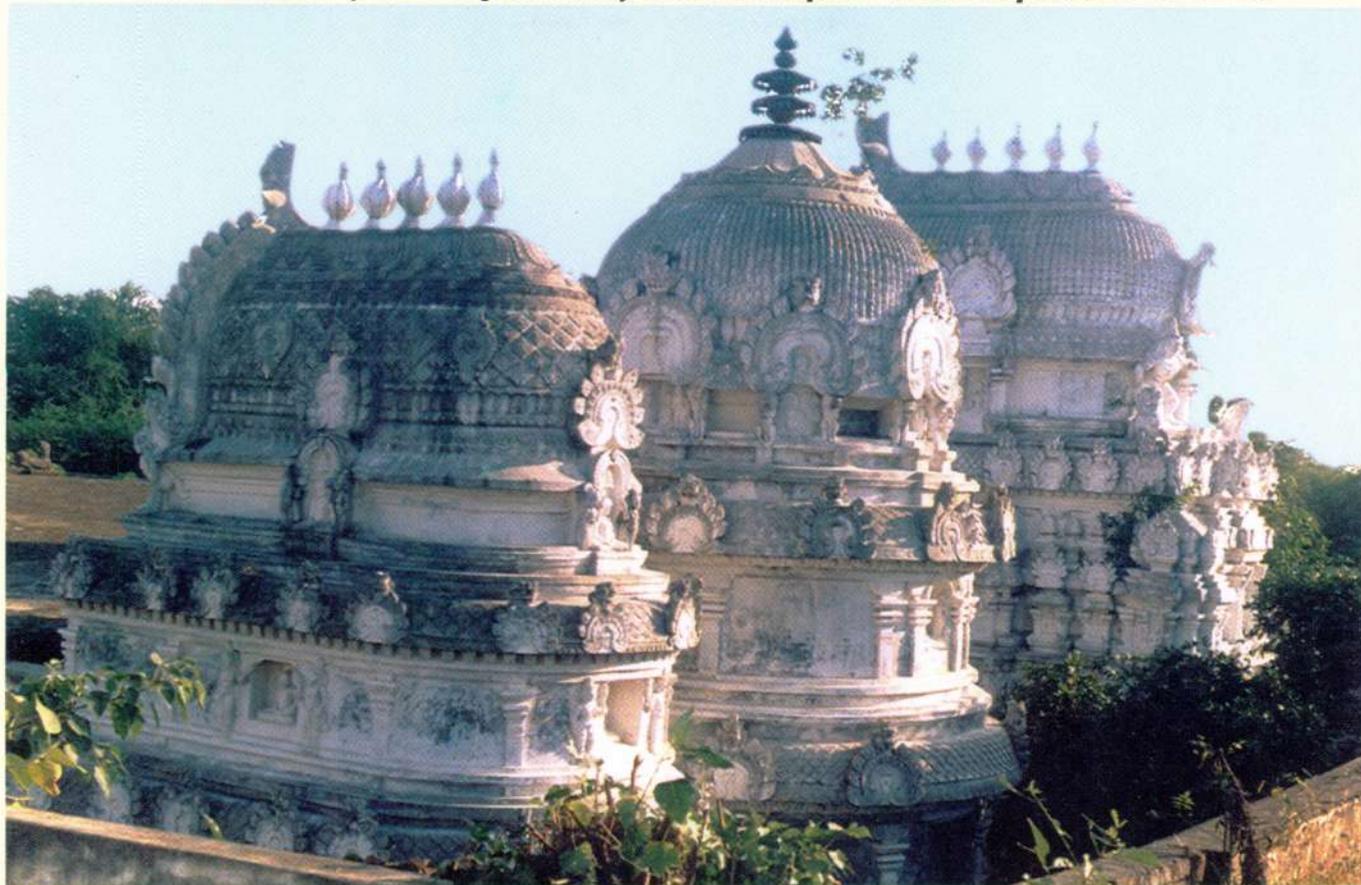
Trailokyanātha temple - Before conservation

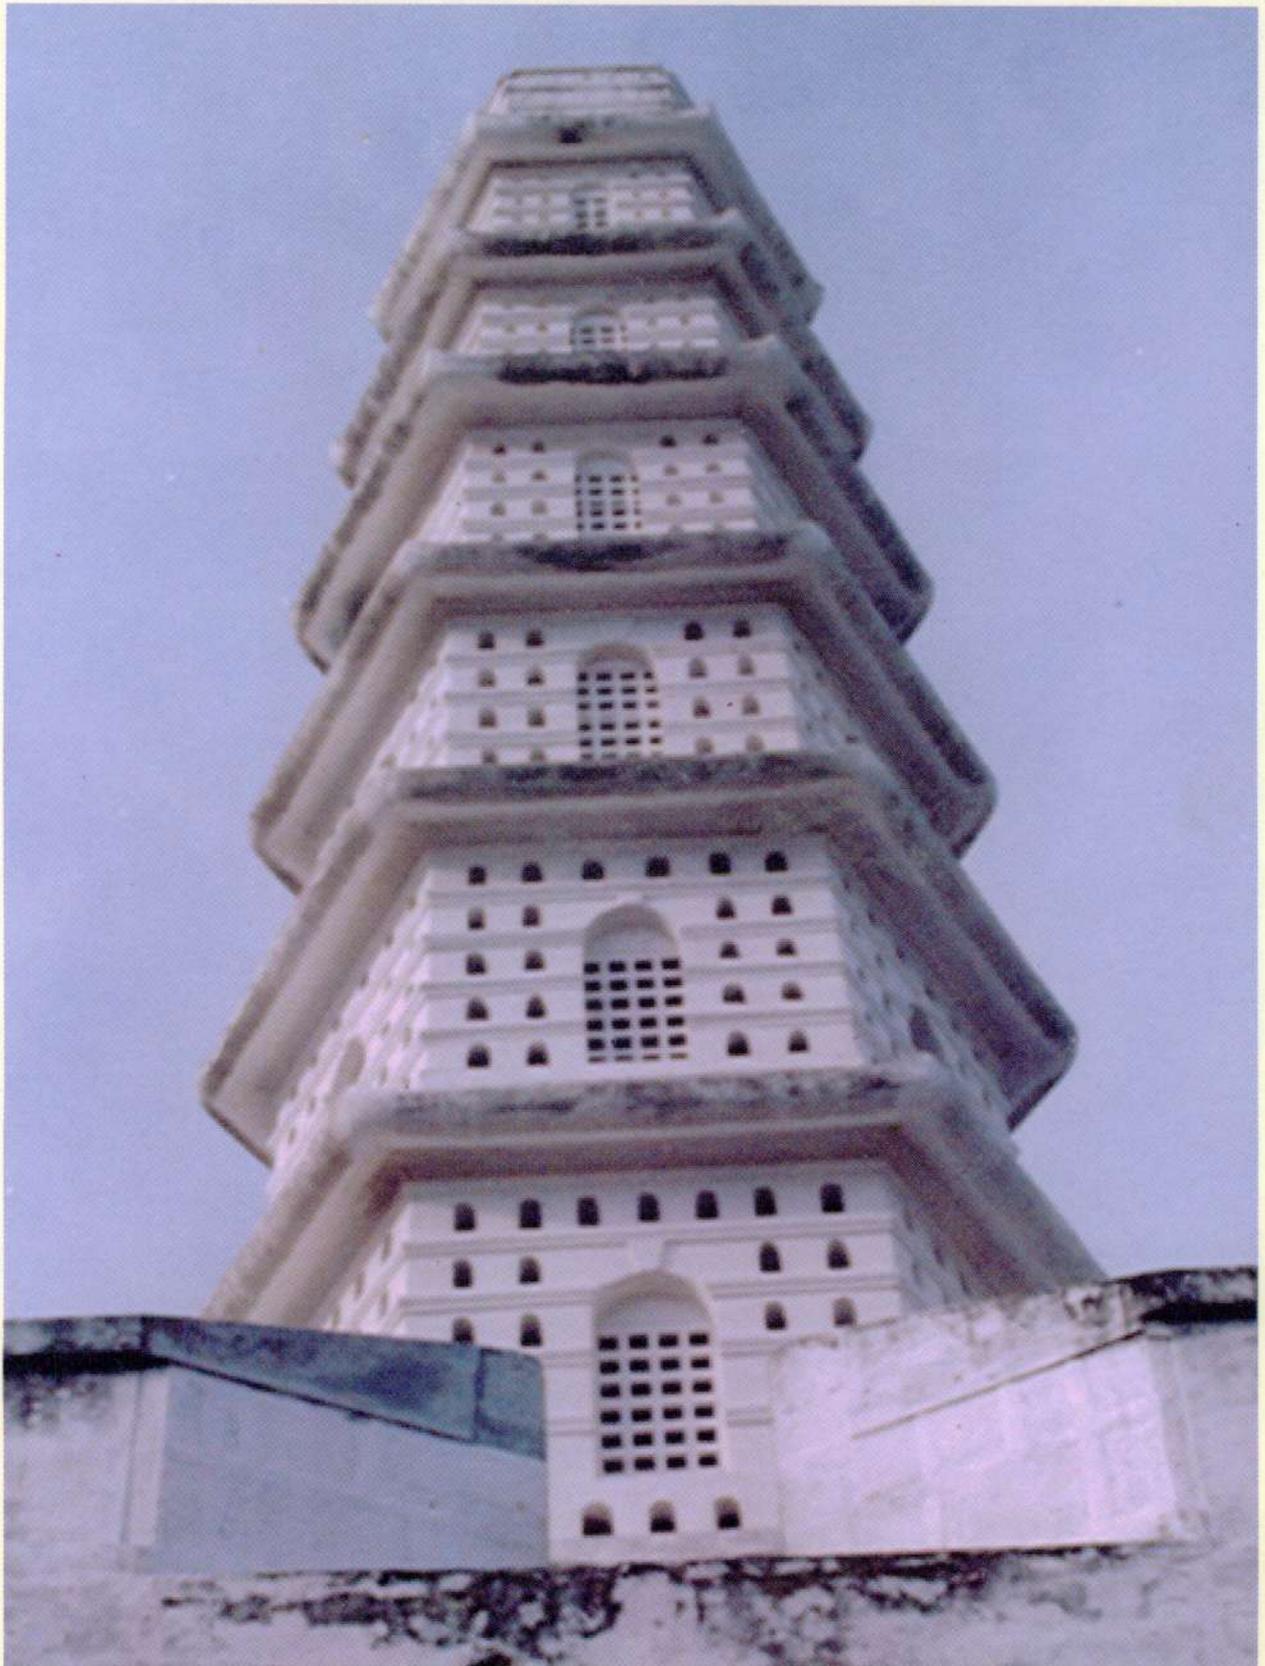
Manora Tower - Before conservation

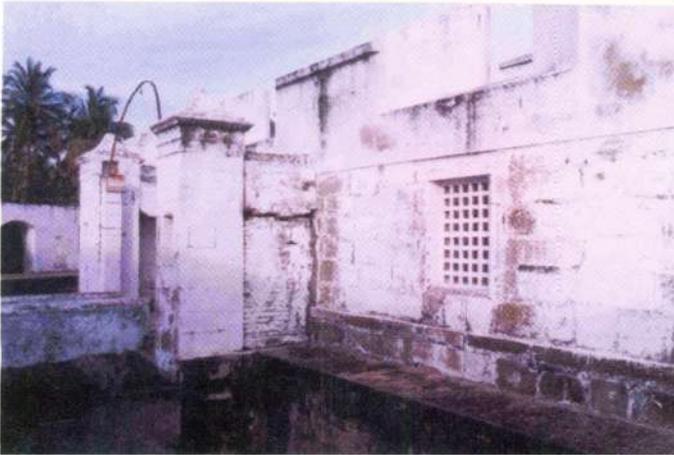
Manora - Before conservation - crack is seen

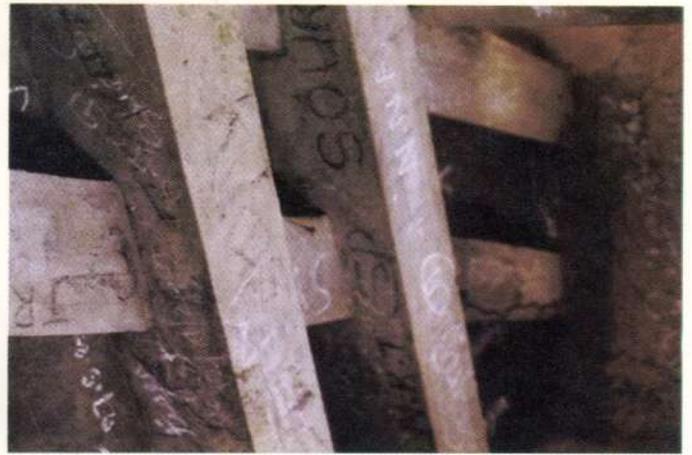
RCC roof support given for Manora resulting in cracks

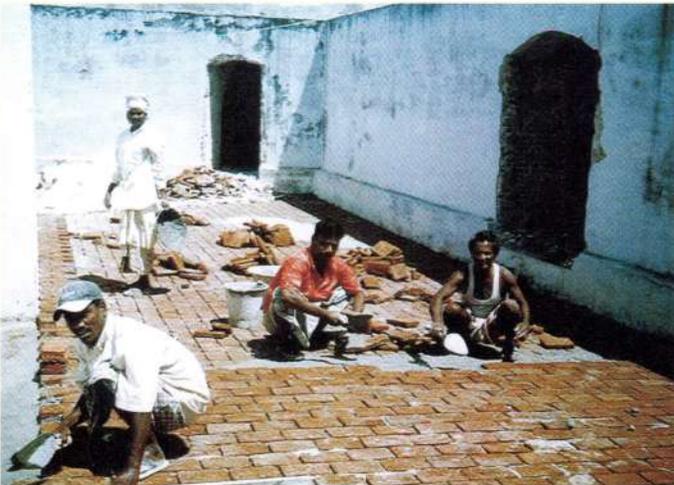
Laying special type of brick floor tiles at Manora

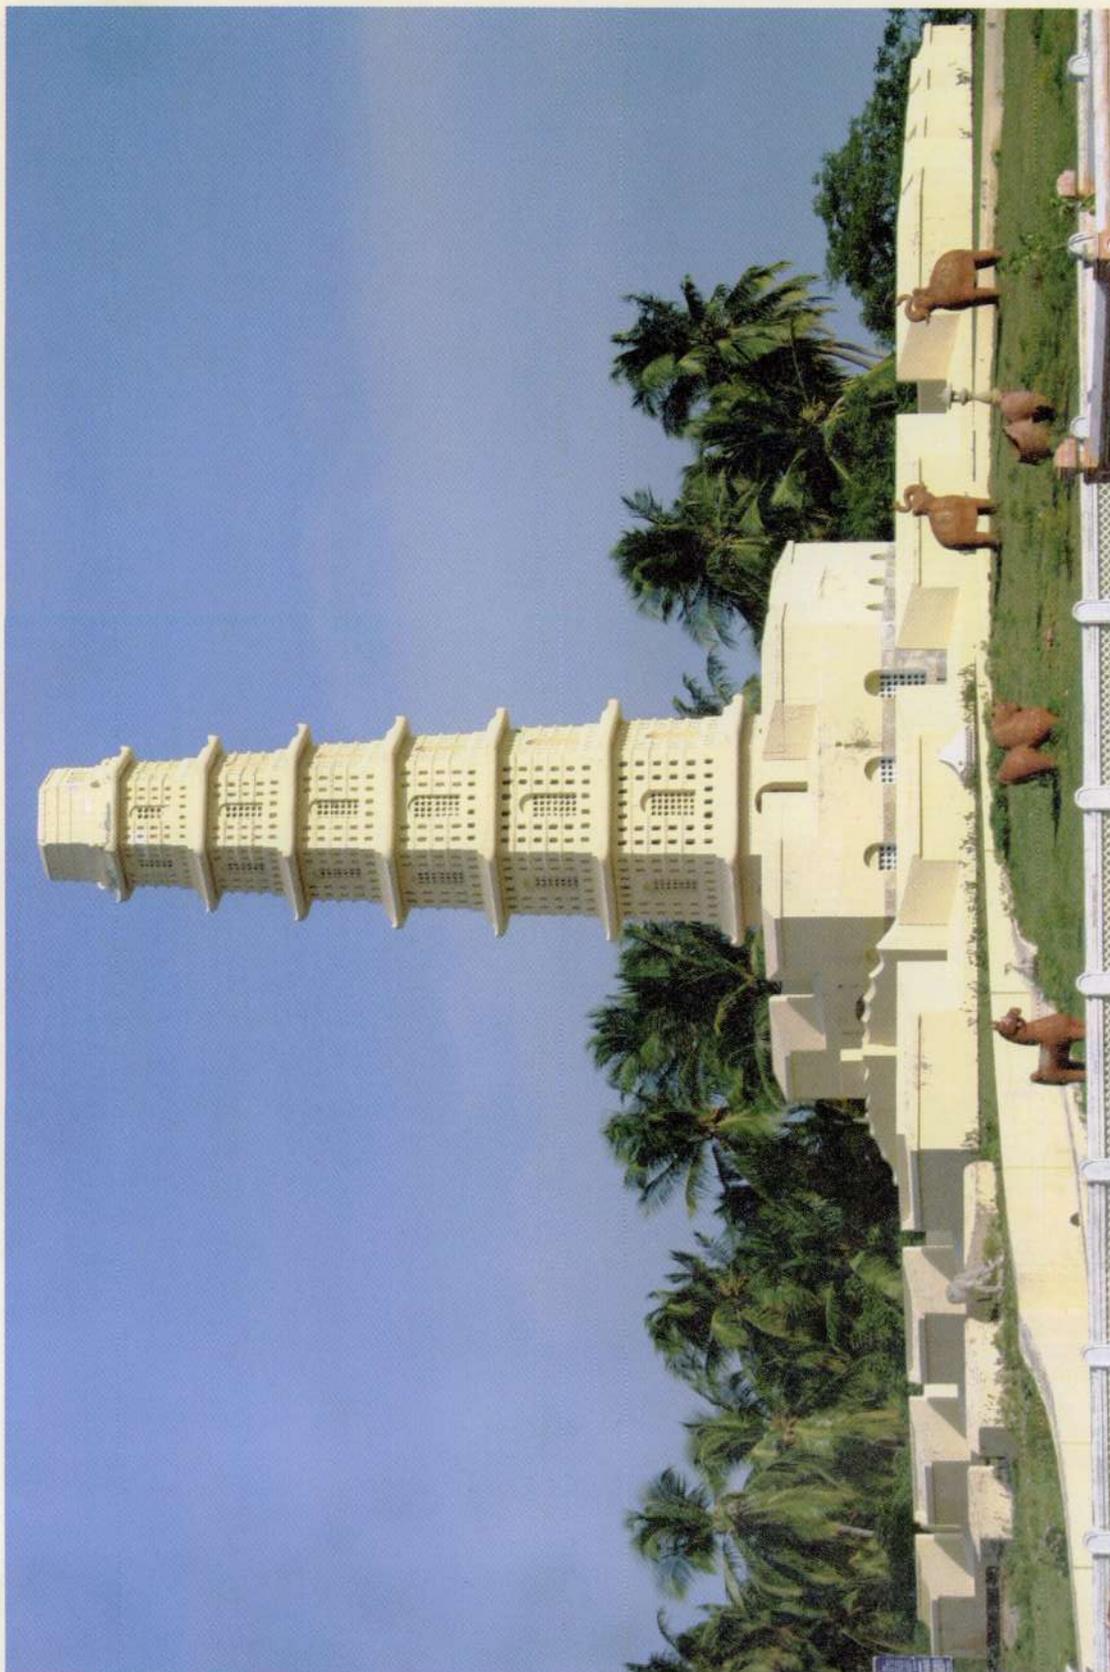
Manora Tower - After conservation

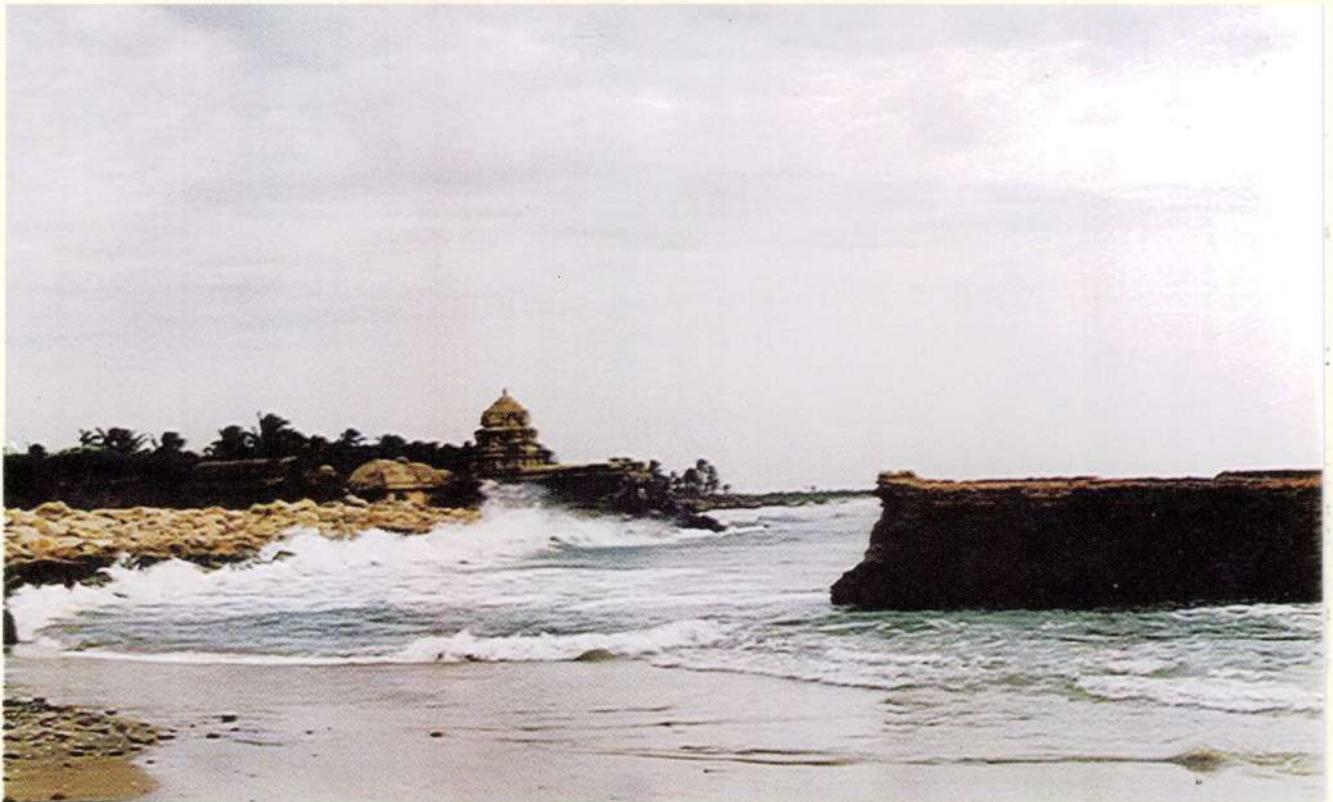
Masilamaninathar temple on the shore of Bay of Bengal at Tranquebar - After Tsunami, 2004

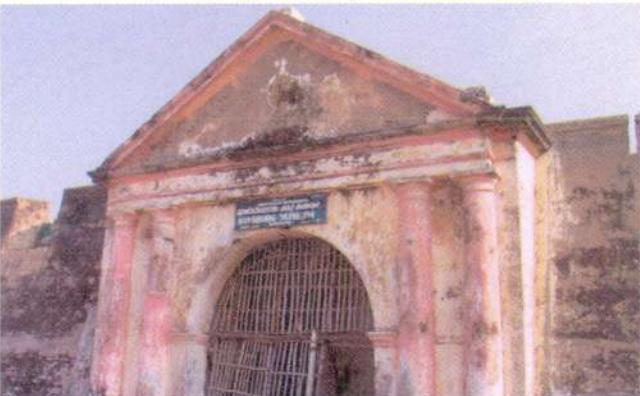
Dansborg entrance - Before conservation

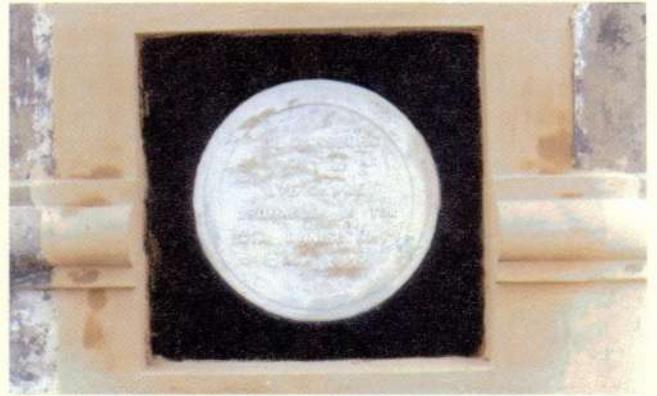
Restored Foundation Slab of Dansborg

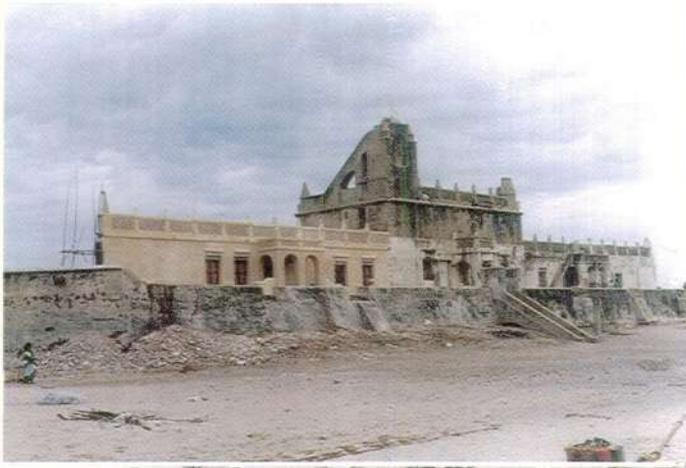
Dansborg - After partial conservation - 2002
The Before and After portions are clearly seen

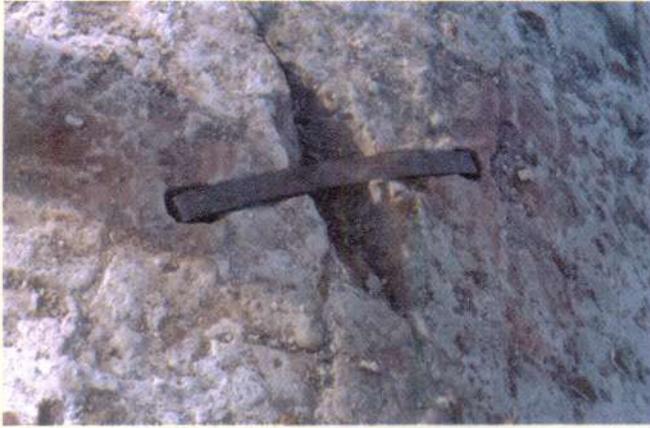
Crack mending method with Copper plate

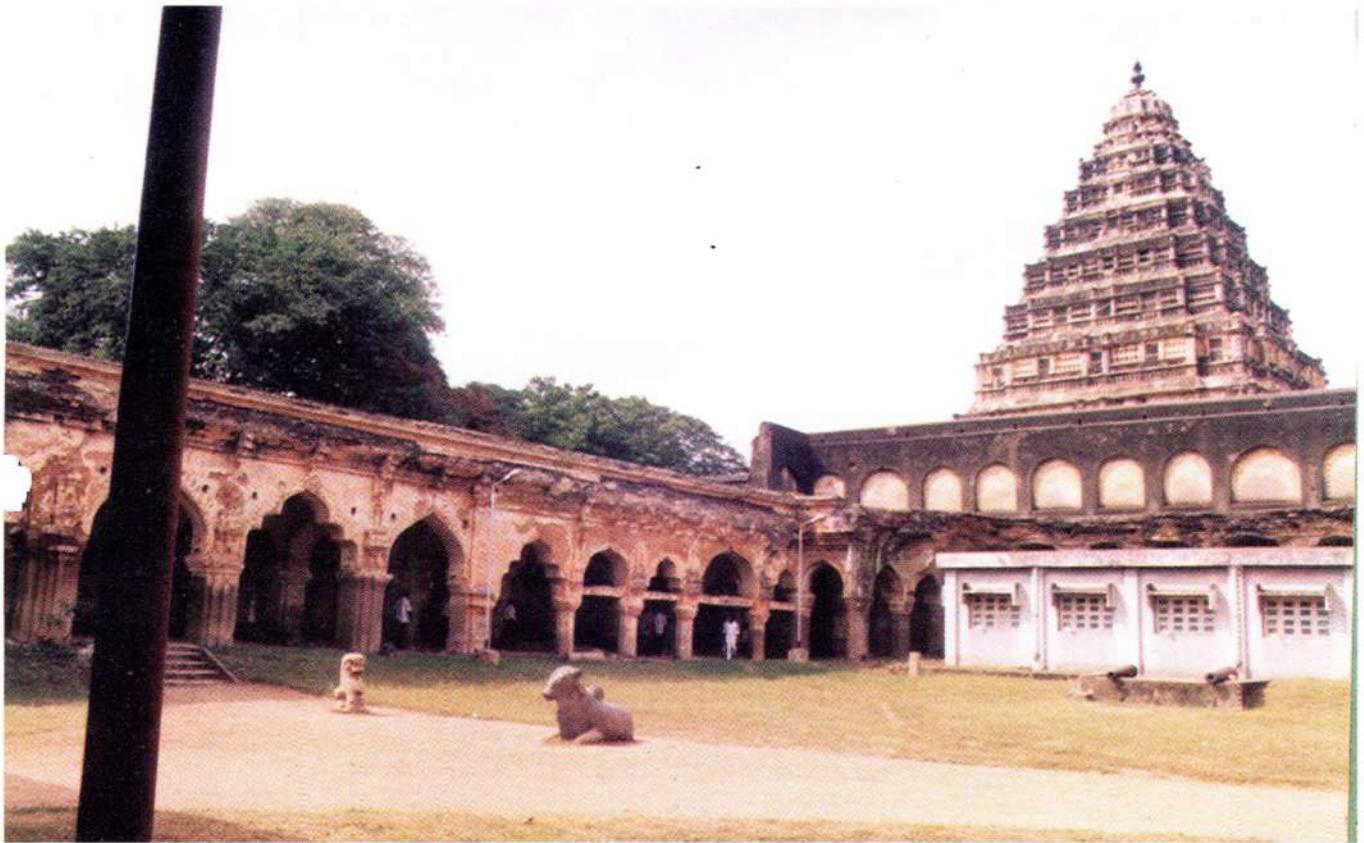
Portion of Thanjavur Palace - Naik Mandapa - Before conservation

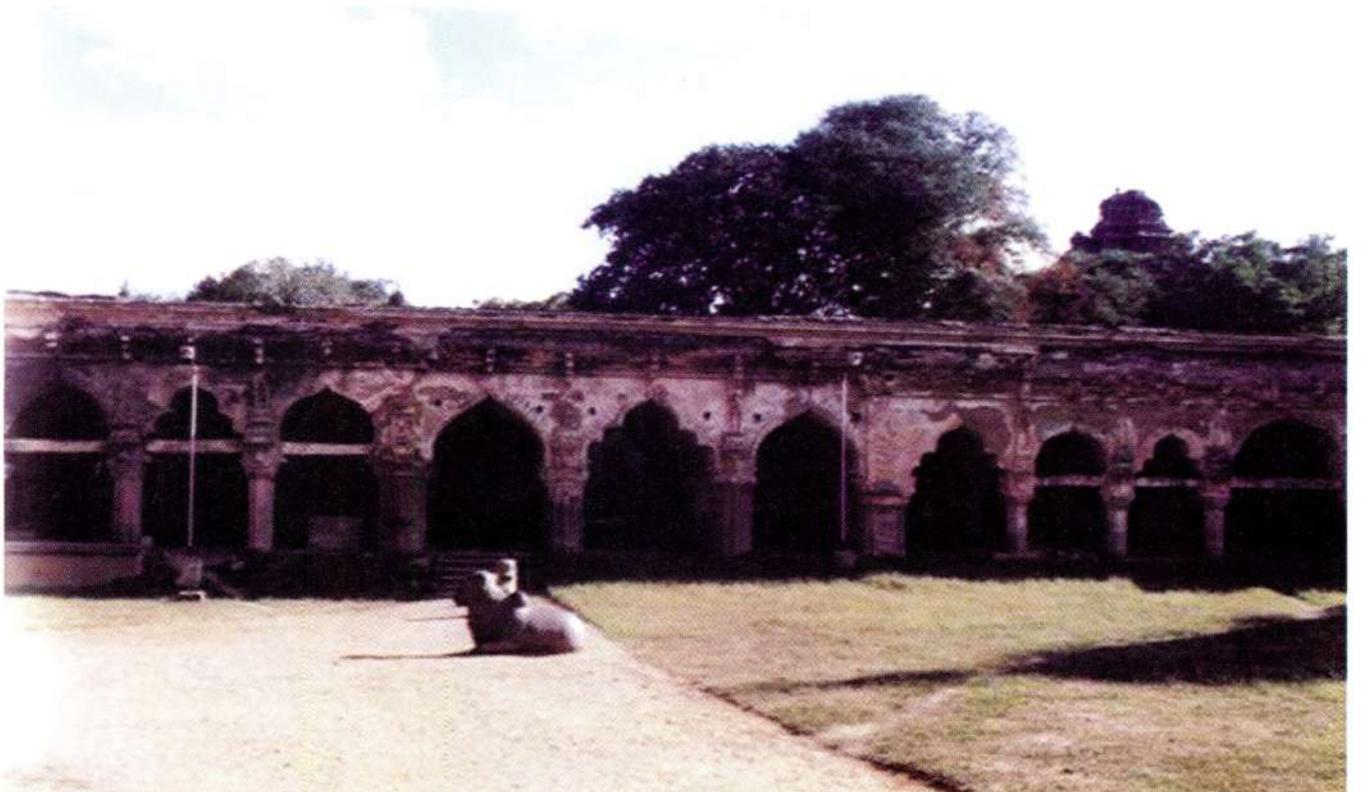
Naik Mandapa at Thanjavur Palace - Before conservation

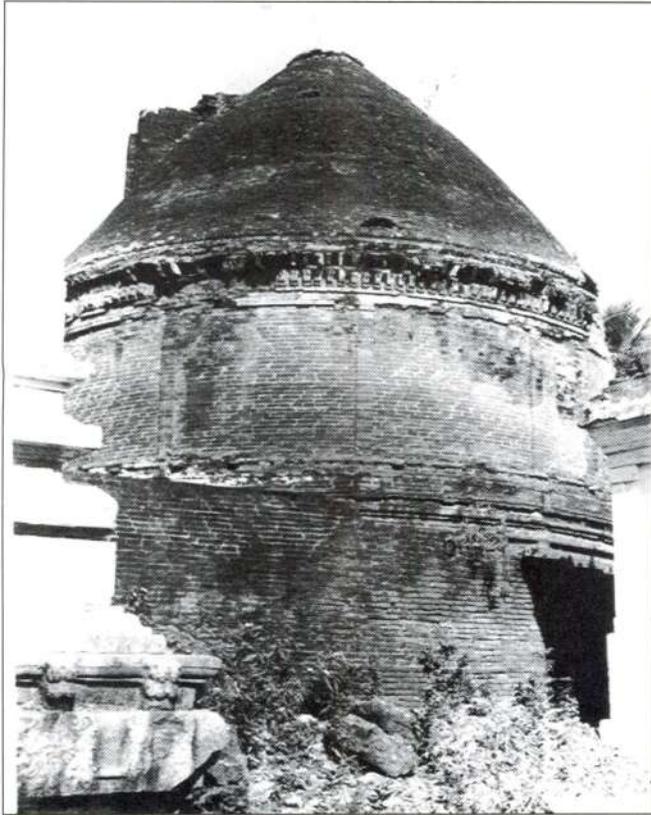
Dilapidated condition of the *Tirupalaithurai* granary

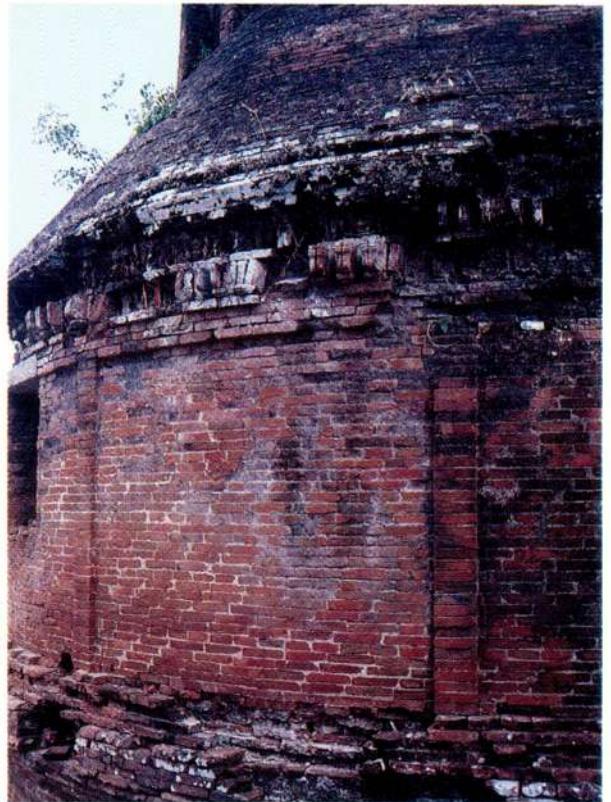
Damaged portions of the granary in closer view

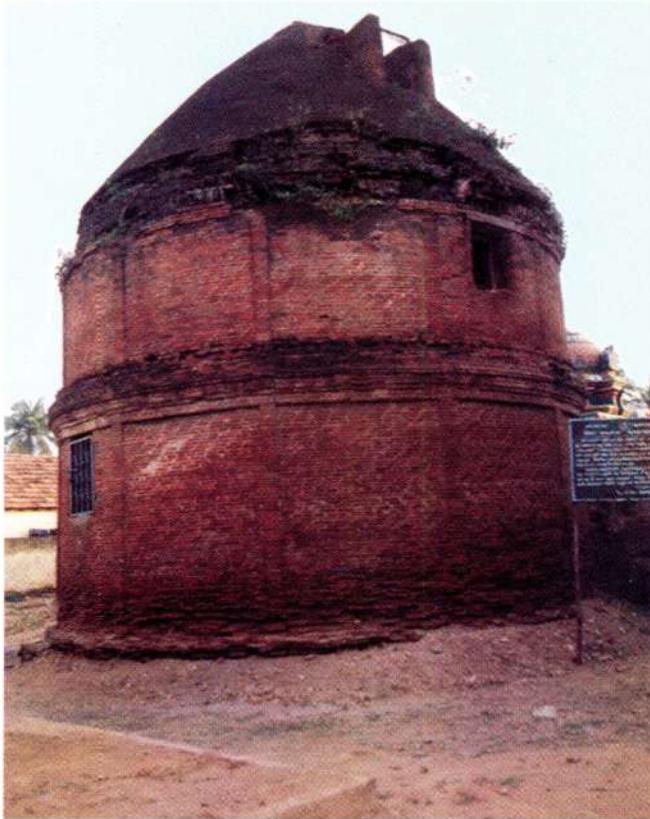
Giant Granary - Before conservation

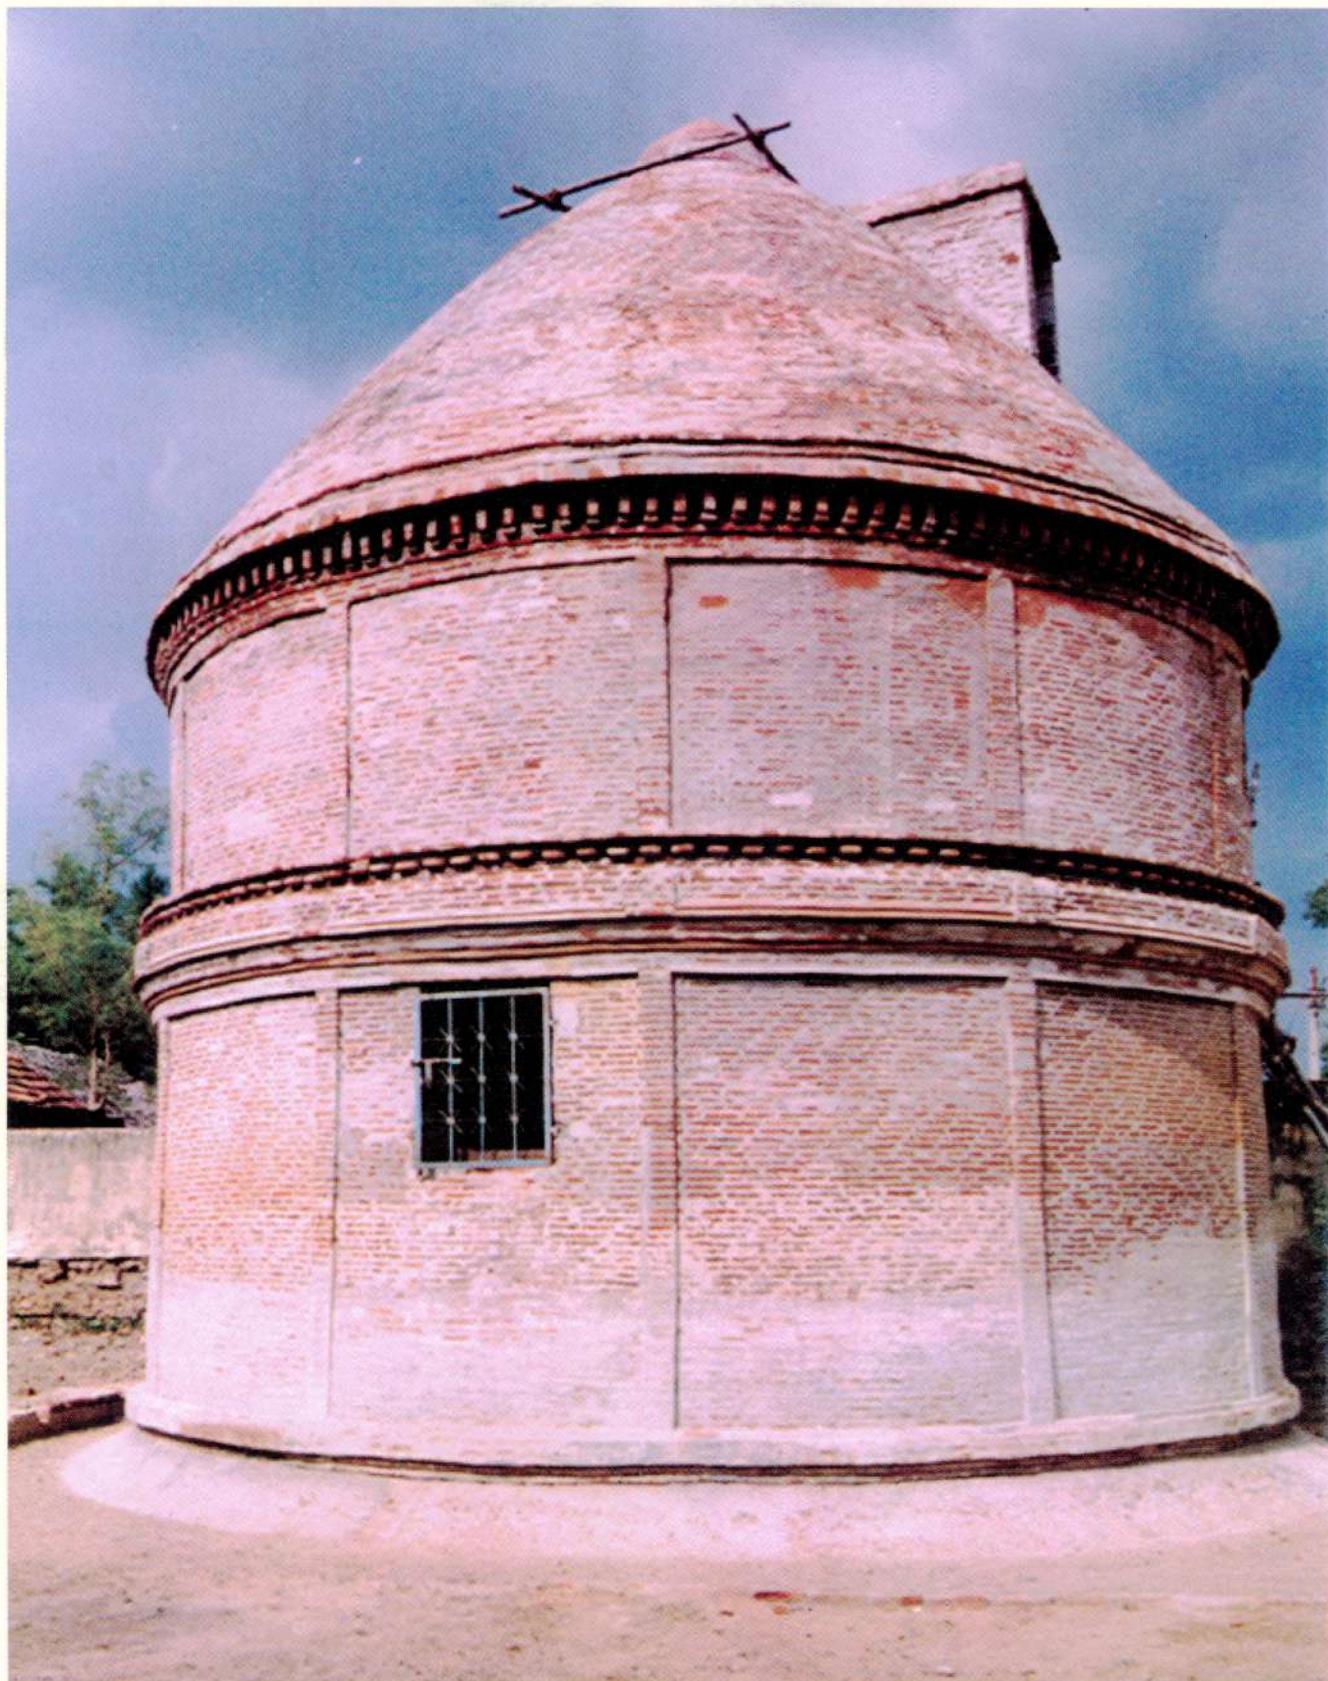
Giant Granary - After conservation

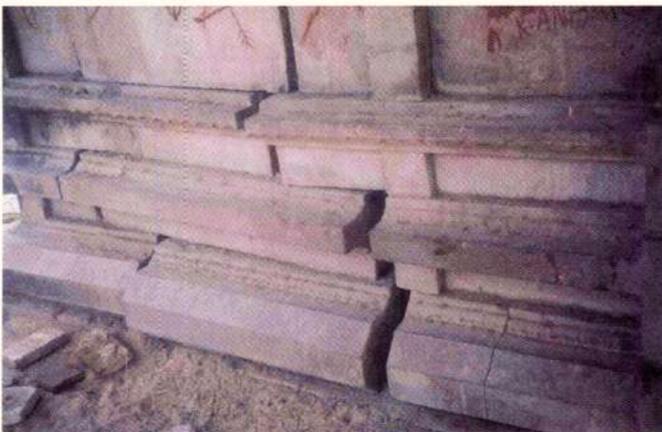
Damaged Upa Peetah

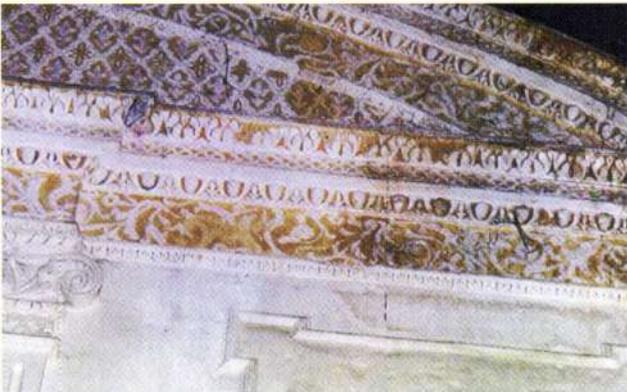
Museum Theatre - Damaged Cornice work - Before

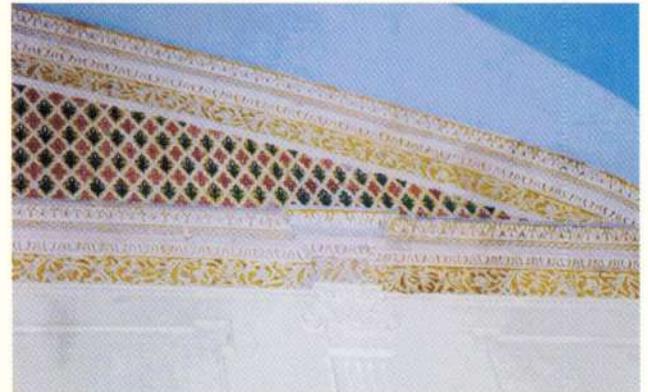
Museum Theatre - Conserved Cornice work - After

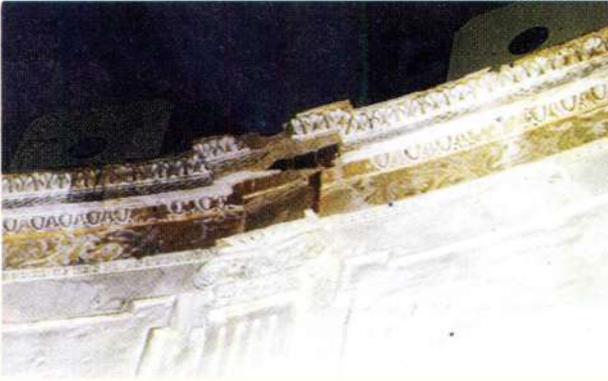
Museum Theatre -Damaged Cornice
- Before conservation

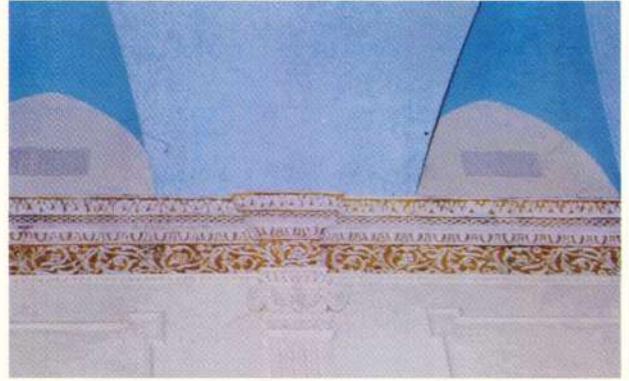
Museum Theatre -Conserved Cornice
- After conservation

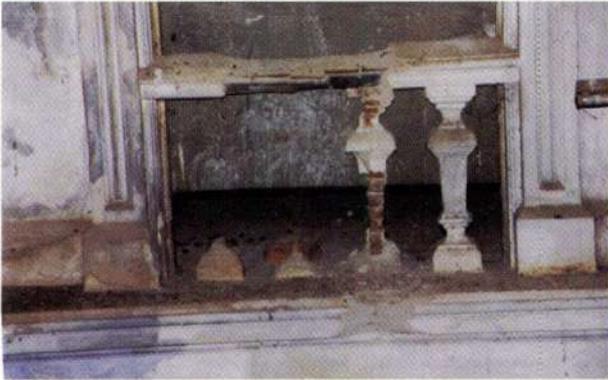
Damaged portion of Museum Theatre

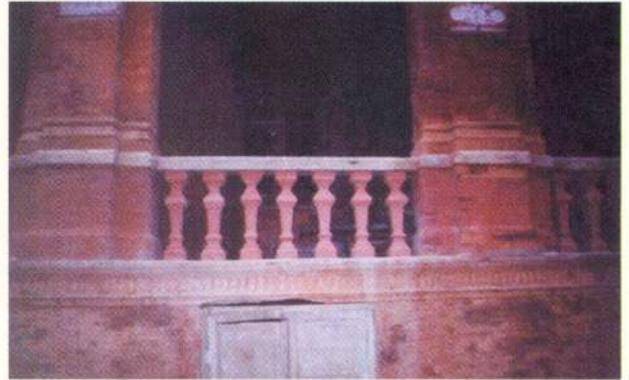
Conserved portion of Museum Theatre

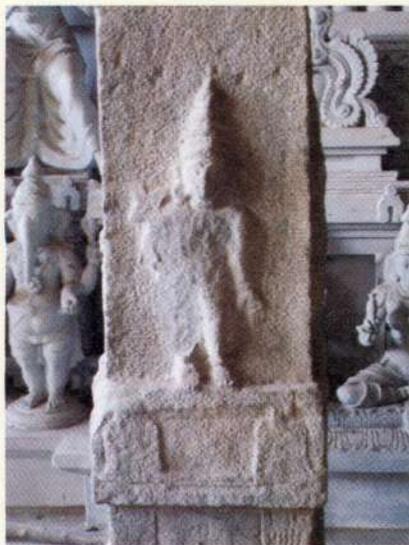
Bad effects of sand blasting, which has resulted in a crack in the bottom part of a pillar near the *Ramana Cave* temple mended by application of cement in the Thousand Pillared *mandapa* of the *Arunachaleswarar* Temple at *Tiruvannamalai*.

Bas relief sculpture badly damaged near the *Ramana Cave* temple in the Thousand Pillared *mandapa*

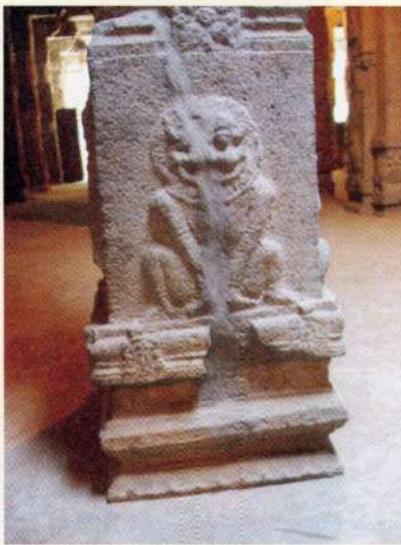
Another instance of damage in the Thousand Pillared *Mandapa* of *Tiruvannamalai* Temple.
