MANUAL ON CONSERVATION AND RESTORATION OF MONUMENTS

Proceedings of an Administrator turned
Conservation Archaeologist cum Museologist

2007

Published by the Government Museum,
Chennai-600 008

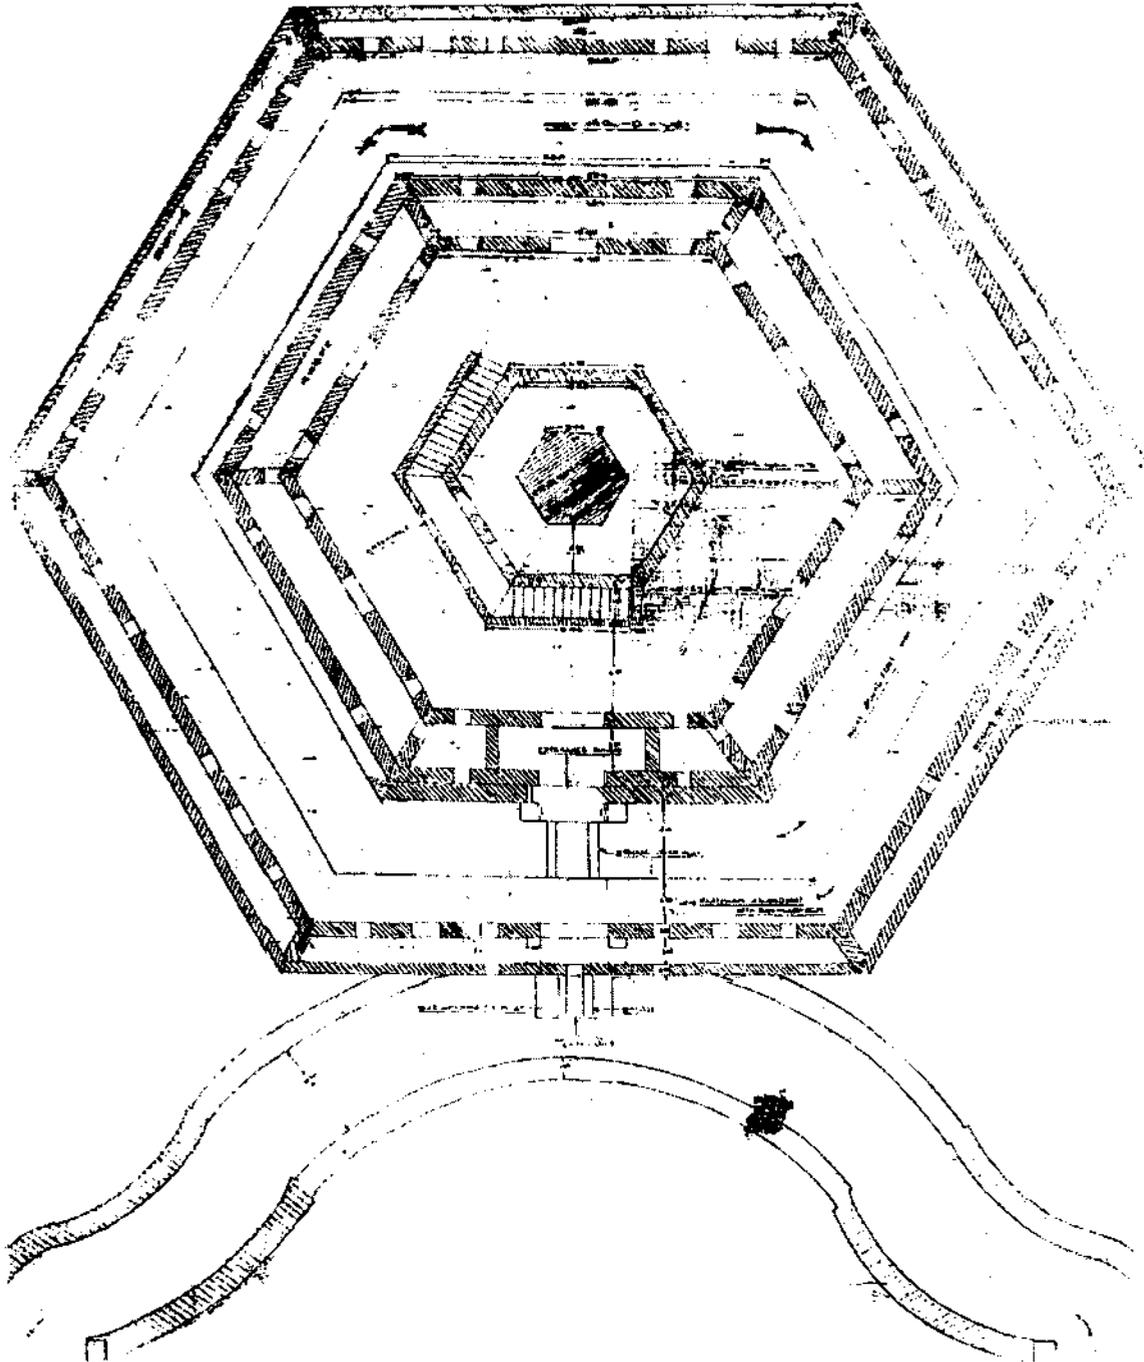
**Manora Elevation
(Fortified Tower)**

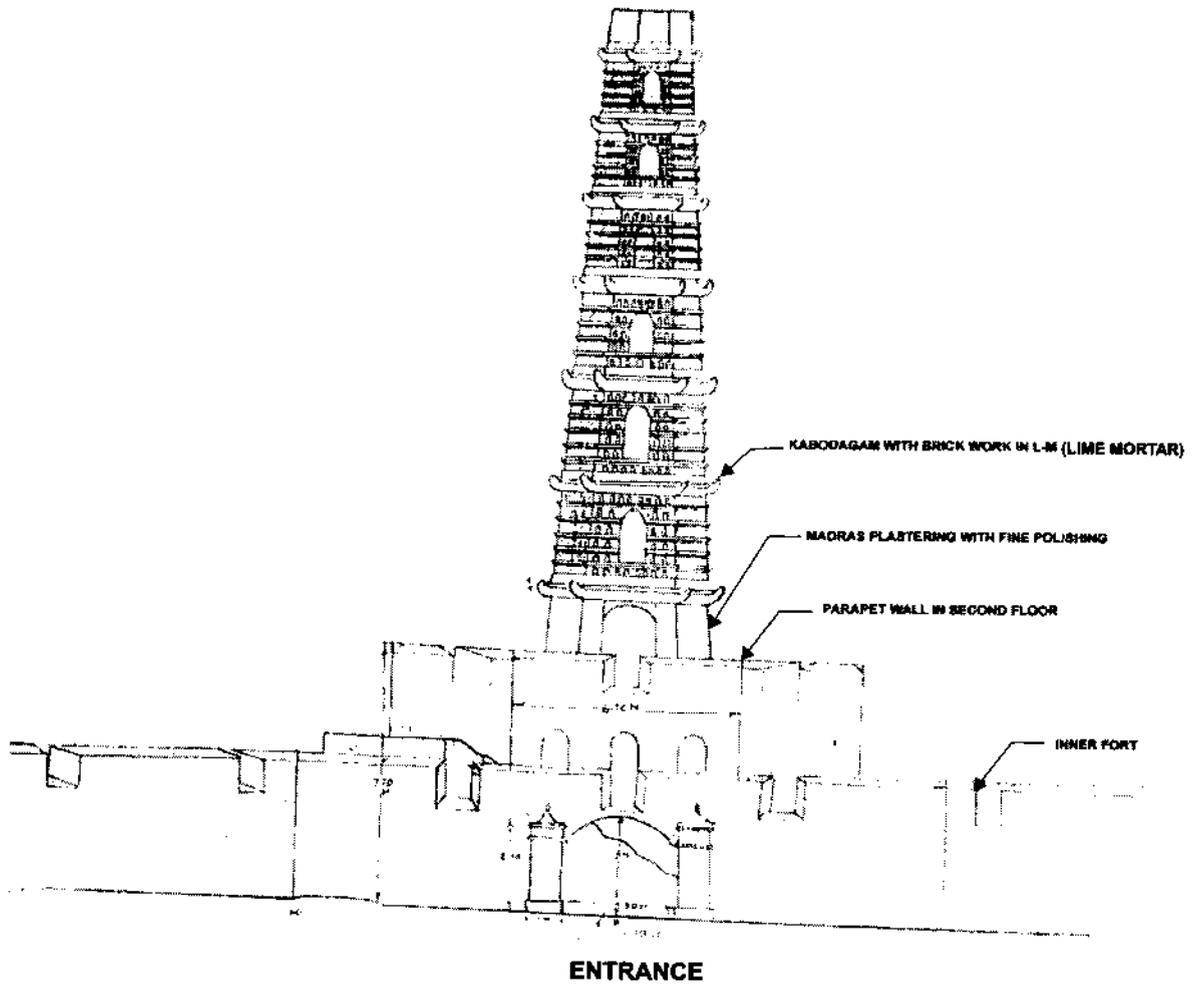
SCALE : 2 CM : 1 M

**Plan showing the I floor of *Manora Fort*
(Fortified Tower)**

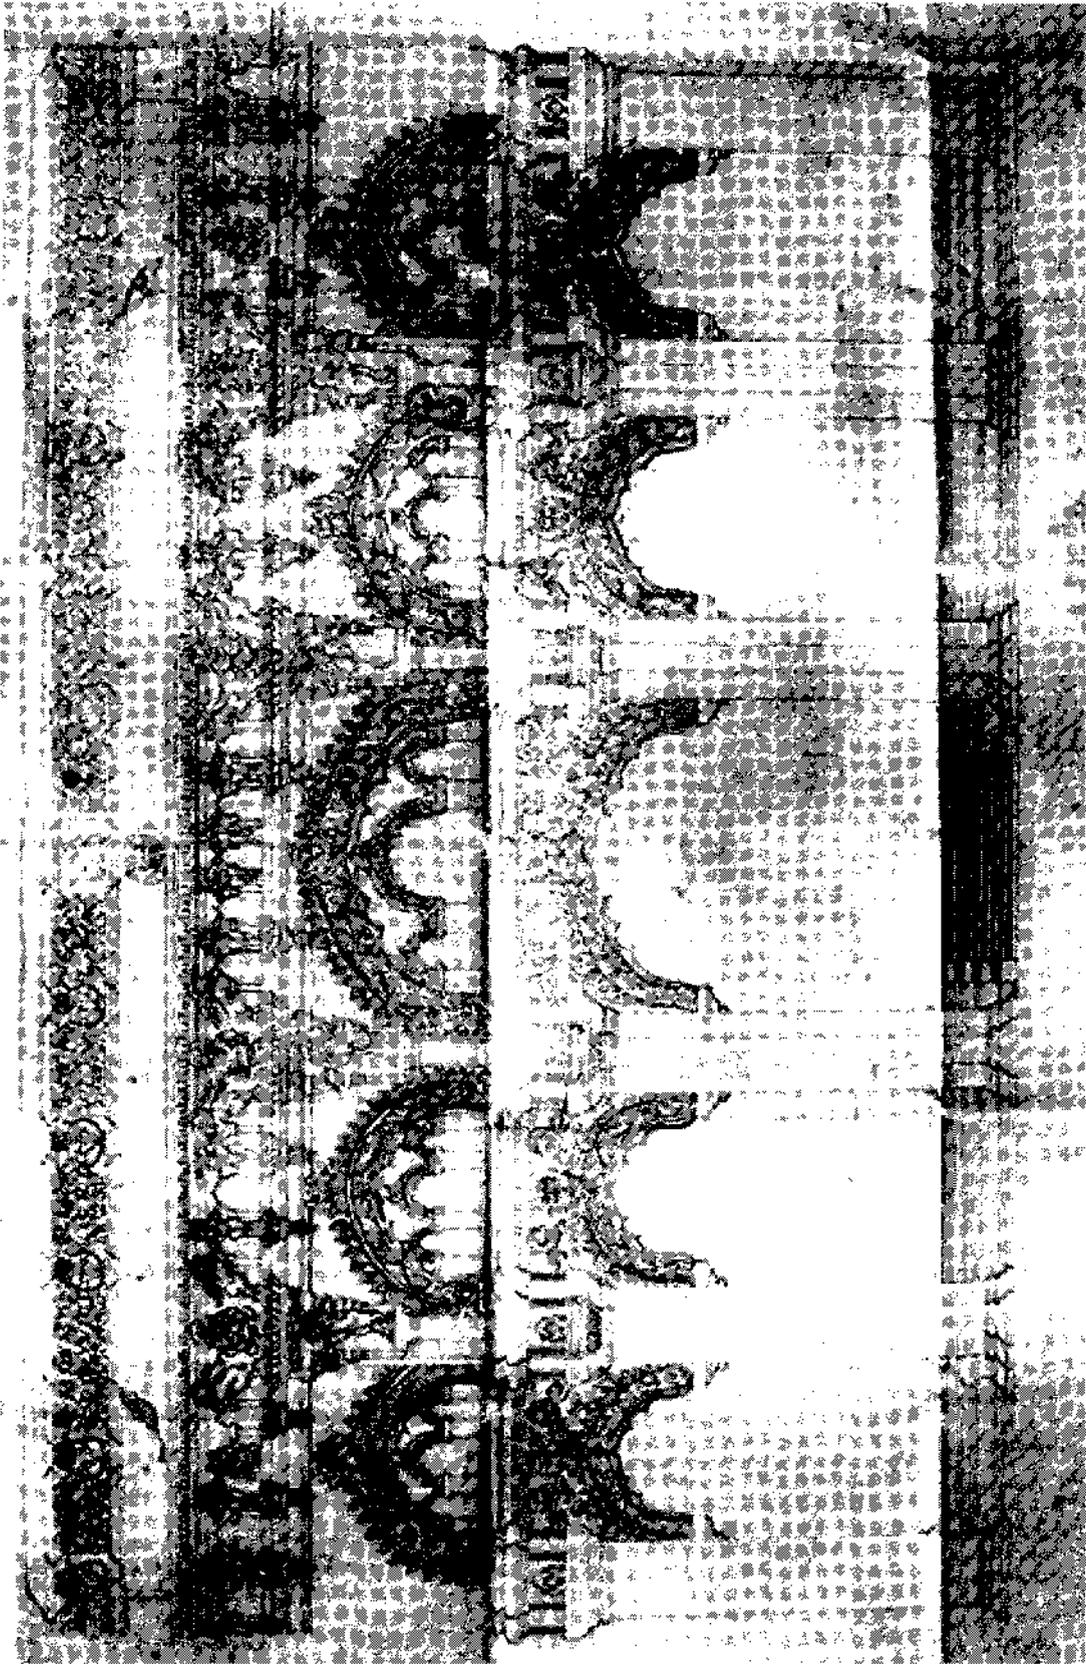
Tirumalai Naik Mahal - Inner Elevation
